LAKE PARSIPPANY DYKE

NO 1

NJ 00356

PHASE 1 INSPECTION REPORT  
NATIONAL DAM SAFETY PROGRAM

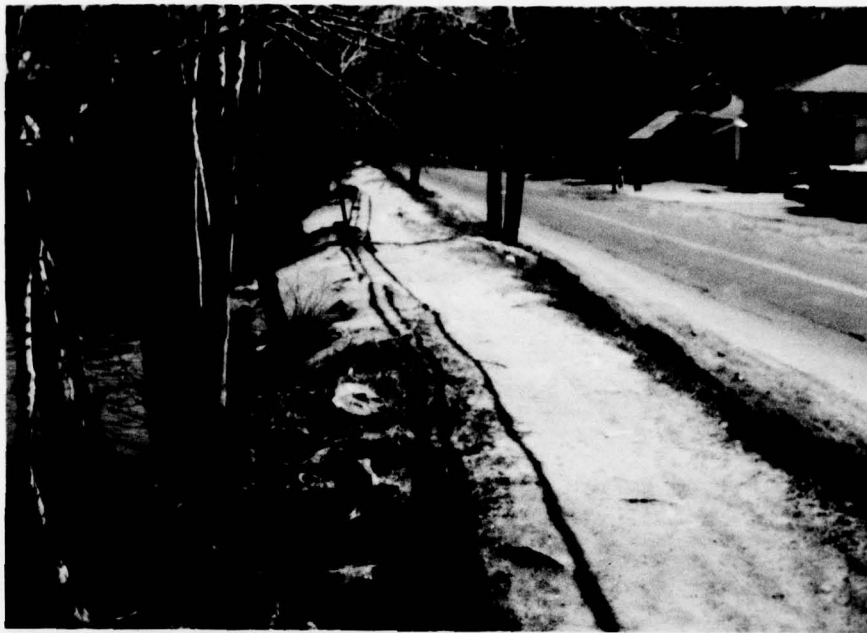
PHOTO 1  
CREST OF DYKE

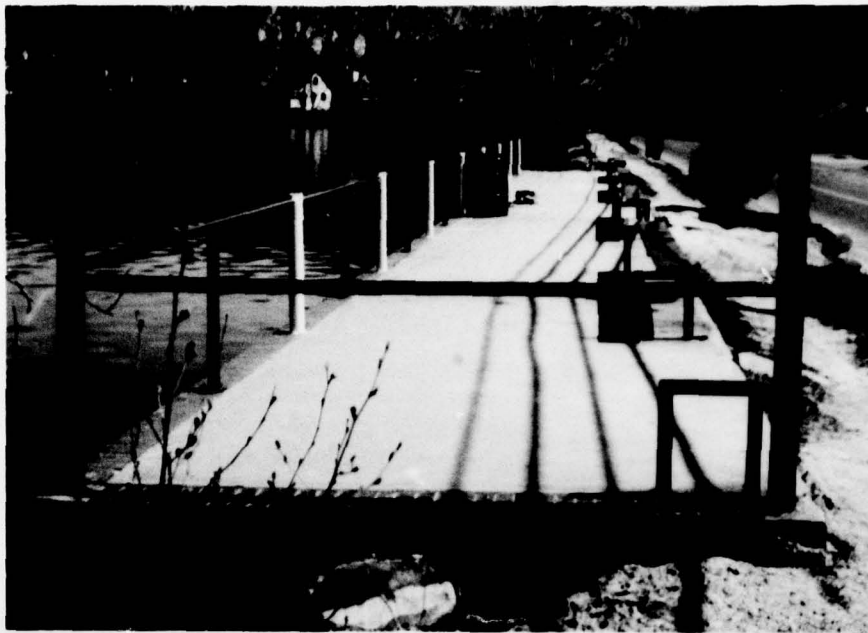
PHOTO 3  
CONCRETE DOCK

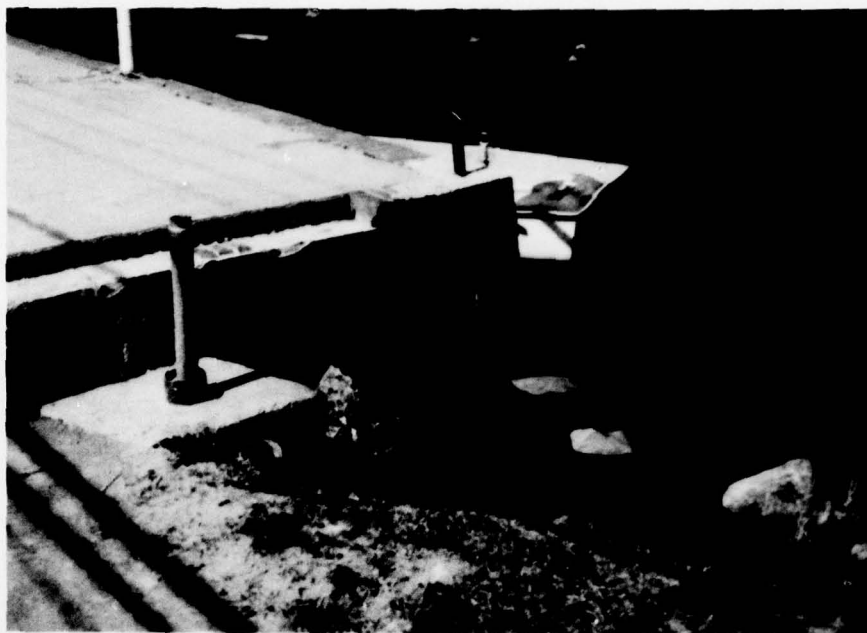
PHOTO 5

DETERIORATION OF SOUTH END OF CONCRETE DOCK

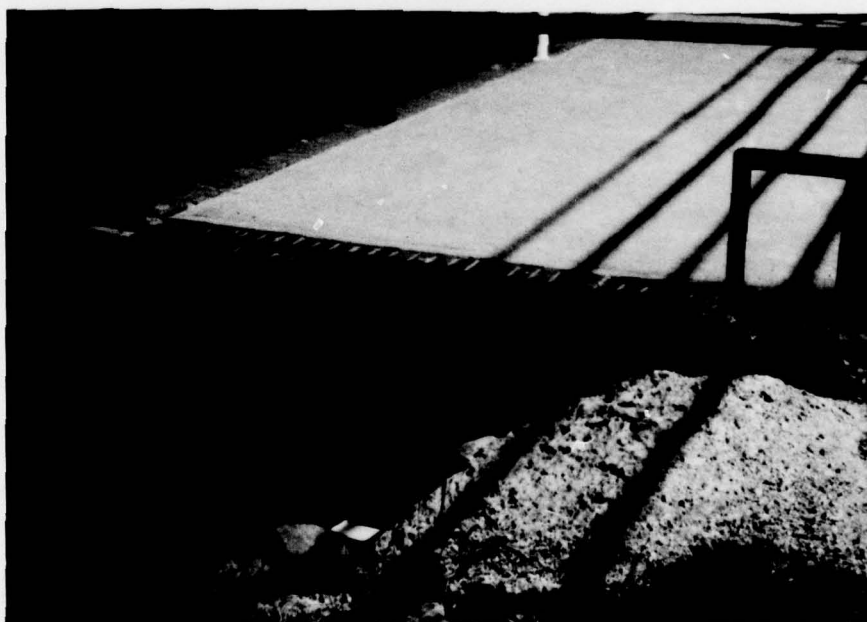
PHOTO 6

DETERIORATION OF NORTH END OF CONCRETE DOCK

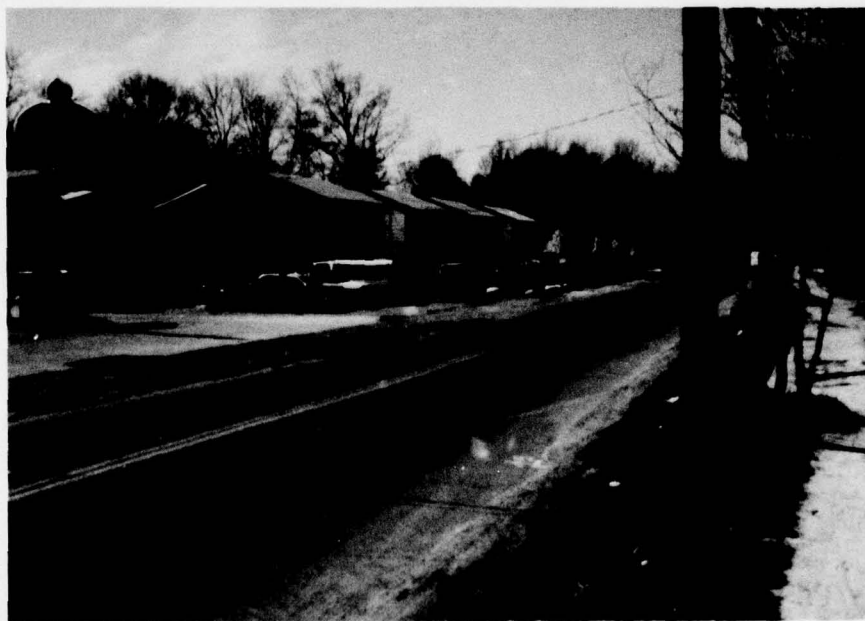
PHOTO 8  
DOWNSTREAM FACE OF DYKE

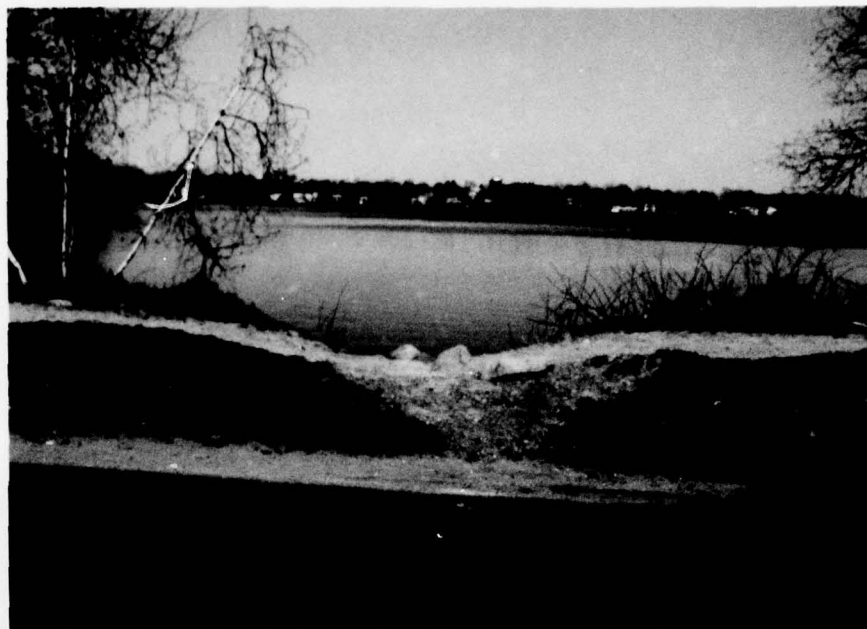
In general, the dyke appeared, at the time of inspection, to be outwardly structurally stable. Low points along the crest of embankment appear to be a result of erosion and not differential settlement. The condition of the timber corewall cannot be observed. The cause of the slope of the concrete dock as described in paragraph 3.1.b is not outwardly apparent.

PHOTO 9  
EROSION OF CREST OF DYKE

(3) The dyke crest should be protected from pedestrian traffic by an appropriate pavement.

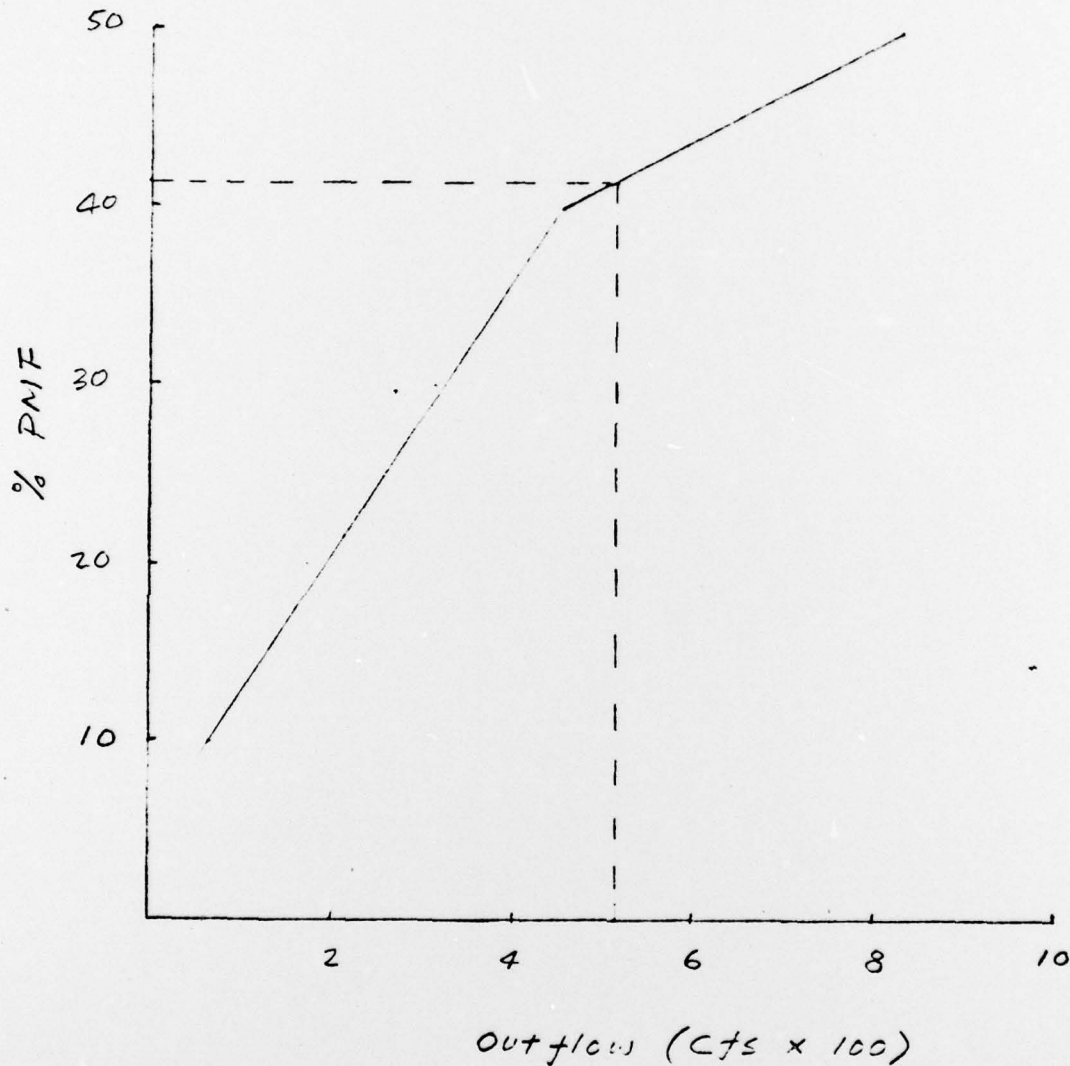
Overtopping occurs at elev. 296 with  $Q = 514$  cfs

$\therefore$  Combination of dam and two dykes can pass approx. 41.5 % PMF.
